Bike and Pedestrian Safety Recommendations Technical Memorandum

April 27, 2023

CITY OF
ORLANDO

SOUTHWEST BIKE AND PEDESTRIAN STUDY

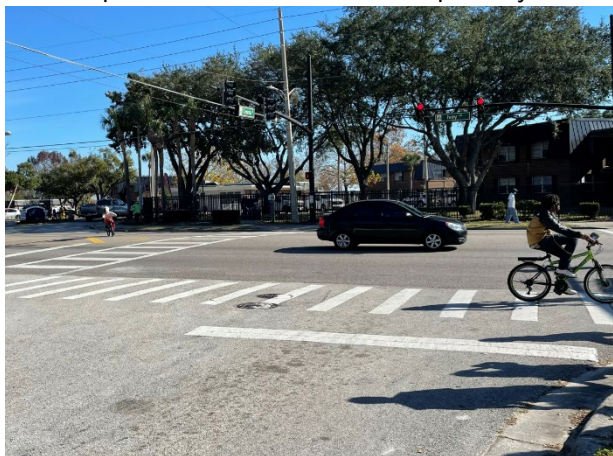
- The side street (Cypress Street) green phase was observed to occur only when a motorist approaches Ivey Lane from the west. Given the very low side street volumes observed, this leads to long cycles which

Pedestrian crossing against traffic at intersection of Cypress Street and Ivey Lane.

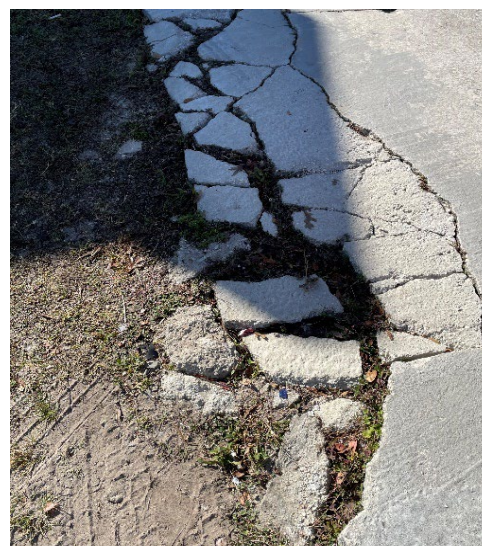
Cracked and separated sidewalk along Ivey Lane.

- Consider narrowing or eliminating the grass buffer between the roadway and the sidewalk to create sidewalk widths similar to those found in the MetroWest development (typically seven feet)
- Refresh pavement markings, particularly bike lane symbols
- Consider green pavement markings for bike lanes at key motorist-bicyclist conflict points
- Trim overgrown vegetation and repair broken sidewalks along the Malibu Street portion of the corridor

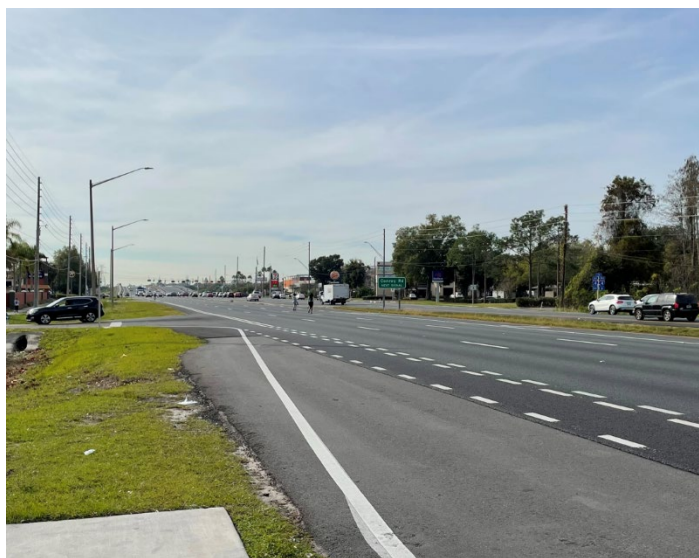
Opportunities for controlled crossings of Kirkman Road are very limited, with no such crossings present between the segment's two boundary intersections. People frequently cross midblock or at unmarked, uncontrolled intersections along this section of Kirkman Road, and several crashes associated with these types of movements have occurred. Because RRFBs are inappropriate for a high-speed, six-lane roadway, options for enhanced crossings are limited to PHBs and full signalization. Most observed mid-block crossings are generated by the multi-family residential developments on both sides of Kirkman Road. This fact suggests that any controlled crossing would be most beneficial at driveways, which further eliminates PHBs as an alternative in accordance with the FDOT *Traffic Engineering Manual* and concerns related to PHBs controlling side street turning movements.

Pedestrians crossing midblock, against traffic.

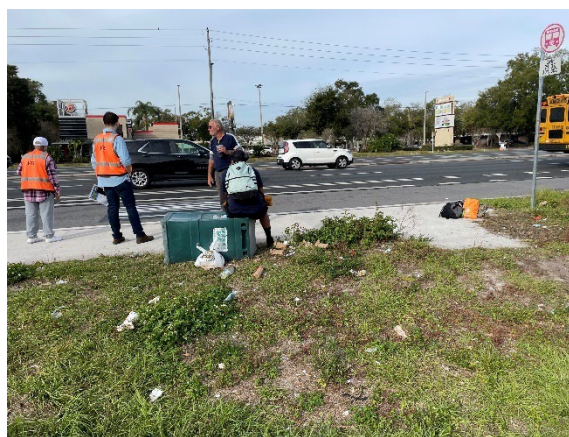
There are six bus stops within the corridor serving four LYNX bus routes, including two routes that operate with 30-minute headways. Until 2020, all six stops included benches and trash receptacles, and three also had covered shelters. As part of recent roadway improvements that included lengthening bus boarding and alighting areas, all bus stop amenities were removed except for one shelter. During the safety audit, numerous passengers were observed either standing or using makeshift items such as an overturned newspaper stand to create a place to sit. At a minimum, previously existing amenities should be restored, and additional amenities (e.g., shelters, bike racks, and system information signing) should be considered.

LYNX riders using an overturned newspaper stand for seating at bus stop on Kirkman Road.

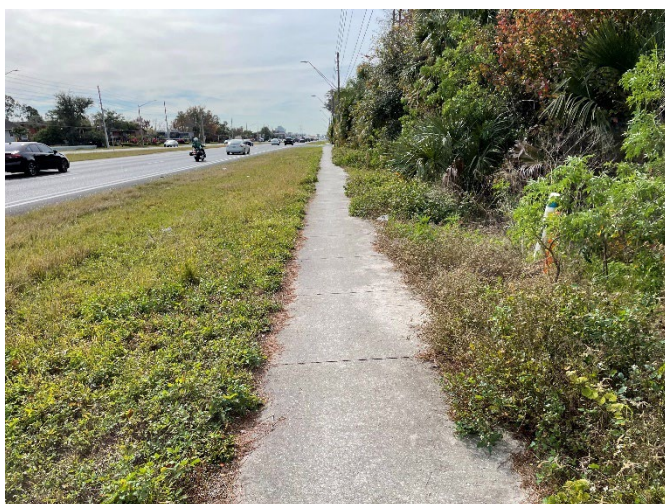
Narrow overgrown sidewalk on west side of Kirkman Road.

- The west side sidewalk is overgrown by vegetation in many places. This vegetation should be trimmed and potential modifications to the maintenance schedule should be considered.
- To improve corridor aesthetics and to provide more visual and physical separation between the roadway and the sidewalk, adding vegetation to the buffer should be considered, potentially in the form of a bioswale.
- The segment’s buffered bike lanes were field measured at as narrow as 5-5.5 feet, which is below the standards identified in the *FDOT Design Manual*.

Investigate opportunities to either narrow vehicular travel lanes or add pavement to widen buffered bike lanes to seven feet (five-foot lane with two-foot buffer).

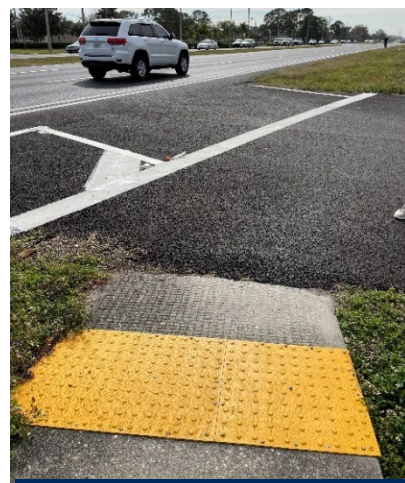
- Detectable warning surfaces at several newer driveways along the corridor are oriented diagonally, which could direct vision-impaired pedestrians toward the roadway. These detectable warnings should be reconfigured.
- The signal phasing at the intersection with L B McLeod Road includes right turn overlap phases during which right turns and U-turns operate concurrently. Signing indicating the U-turns must yield to right turns should be added to mitigate this potential conflict.

Improperly installed blister strips detectable warnings for the visually impaired on sidewalk.

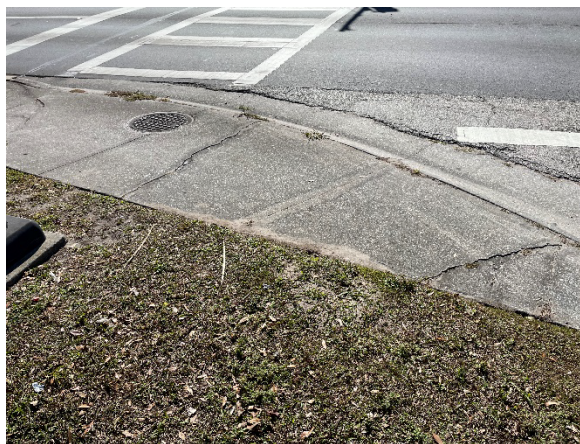
Unclear, unseparated curb ramps.

- In accordance with ADA best practices, separate curb ramps should be created for each directional crossing. At a minimum, detectable warning surfaces should be added to the ramps on the north side of the

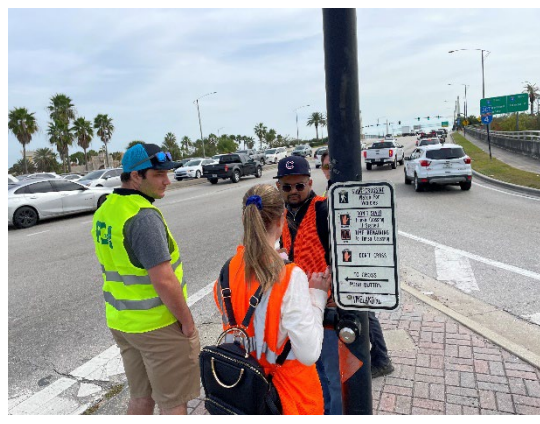
- There are numerous issues with the push button orientation signs that need to be addressed:
 - Signs that are mismatched with their associated buttons
 - Signs that refer to the incorrect roadway being crossed
 - Signs missing orientation arrows under the street name
 - One missing sign at the northeast corner
- Similar to a recommendation for the Kirkman Road/Conroy Road intersection described above, pedestrian WALK intervals for all crossings should be maximized. Currently, the pedestrian clearance interval for the east-west crossing at the south leg of the intersection begins approximately 50 seconds earlier than needed based on the parallel green phase, which unnecessarily increases the likelihood that pedestrians will encounter delay at the intersection.

Mislabeled pedestrian crossing push-button signage.
