**PHASE II
ENVIRONMENTAL SITE ASSESSMENT
PARRAMORE COMMUNITY GARDEN
654 WEST ROBINSON STREET
ORLANDO, FLORIDA**

**The City of Orlando
Economic Development Department
400 S. Orange Avenue
Orlando, Florida 32802-4990
EPA Brownfield Cooperative Agreement BF-95498212**

***ECT* Environmental
Consulting &
Technology, Inc.**
*3660 Maguire Boulevard, Suite 107
Orlando, FL 32803*

**ECT No. 140451.0001
September 2014**

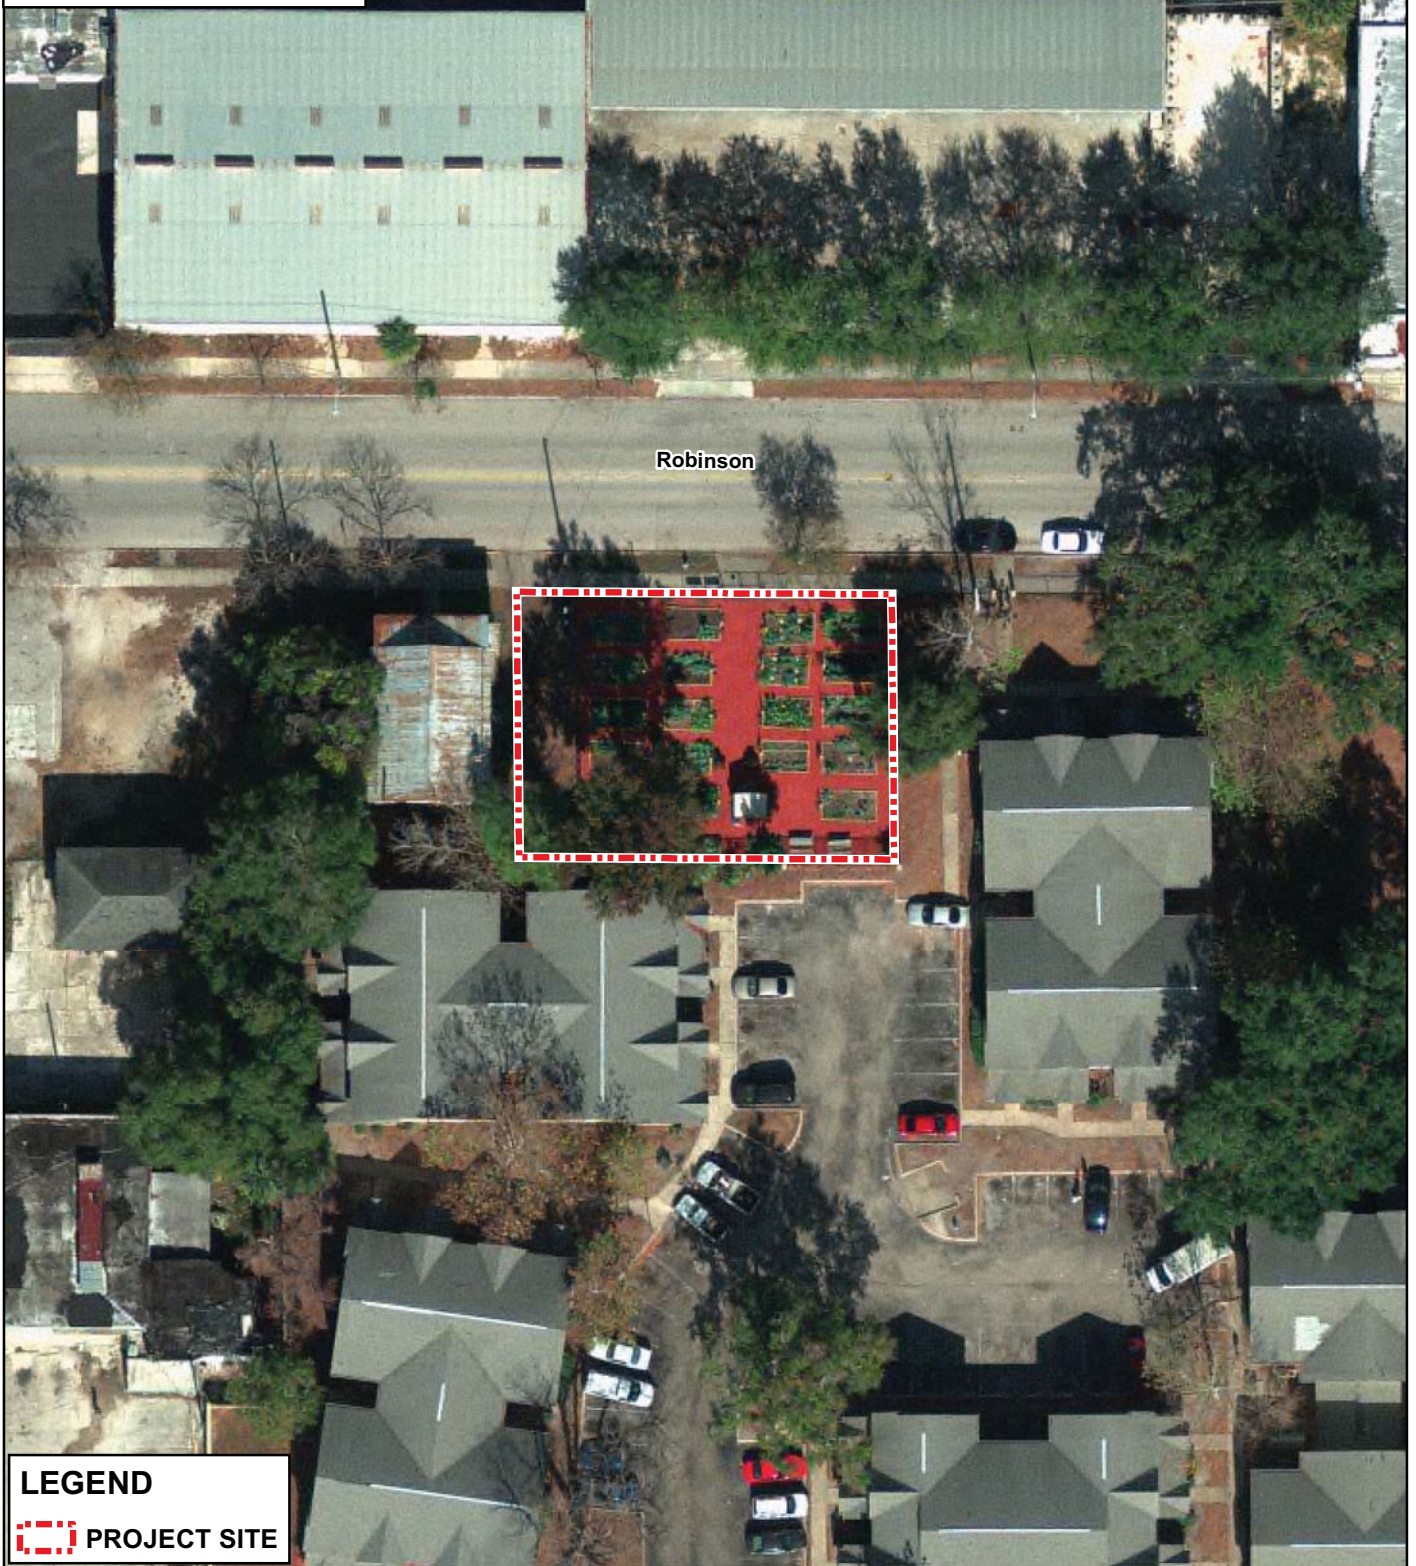
FIGURE 2.
2012 AERIAL PHOTOGRAPH
654 W ROBINSON STREET
ORLANDO, ORANGE COUNTY, FLORIDA
SECTION 26, TOWNSHIP 22S, RANGE 29E
Background Source: FDOT, 2012; ECT, 2014.

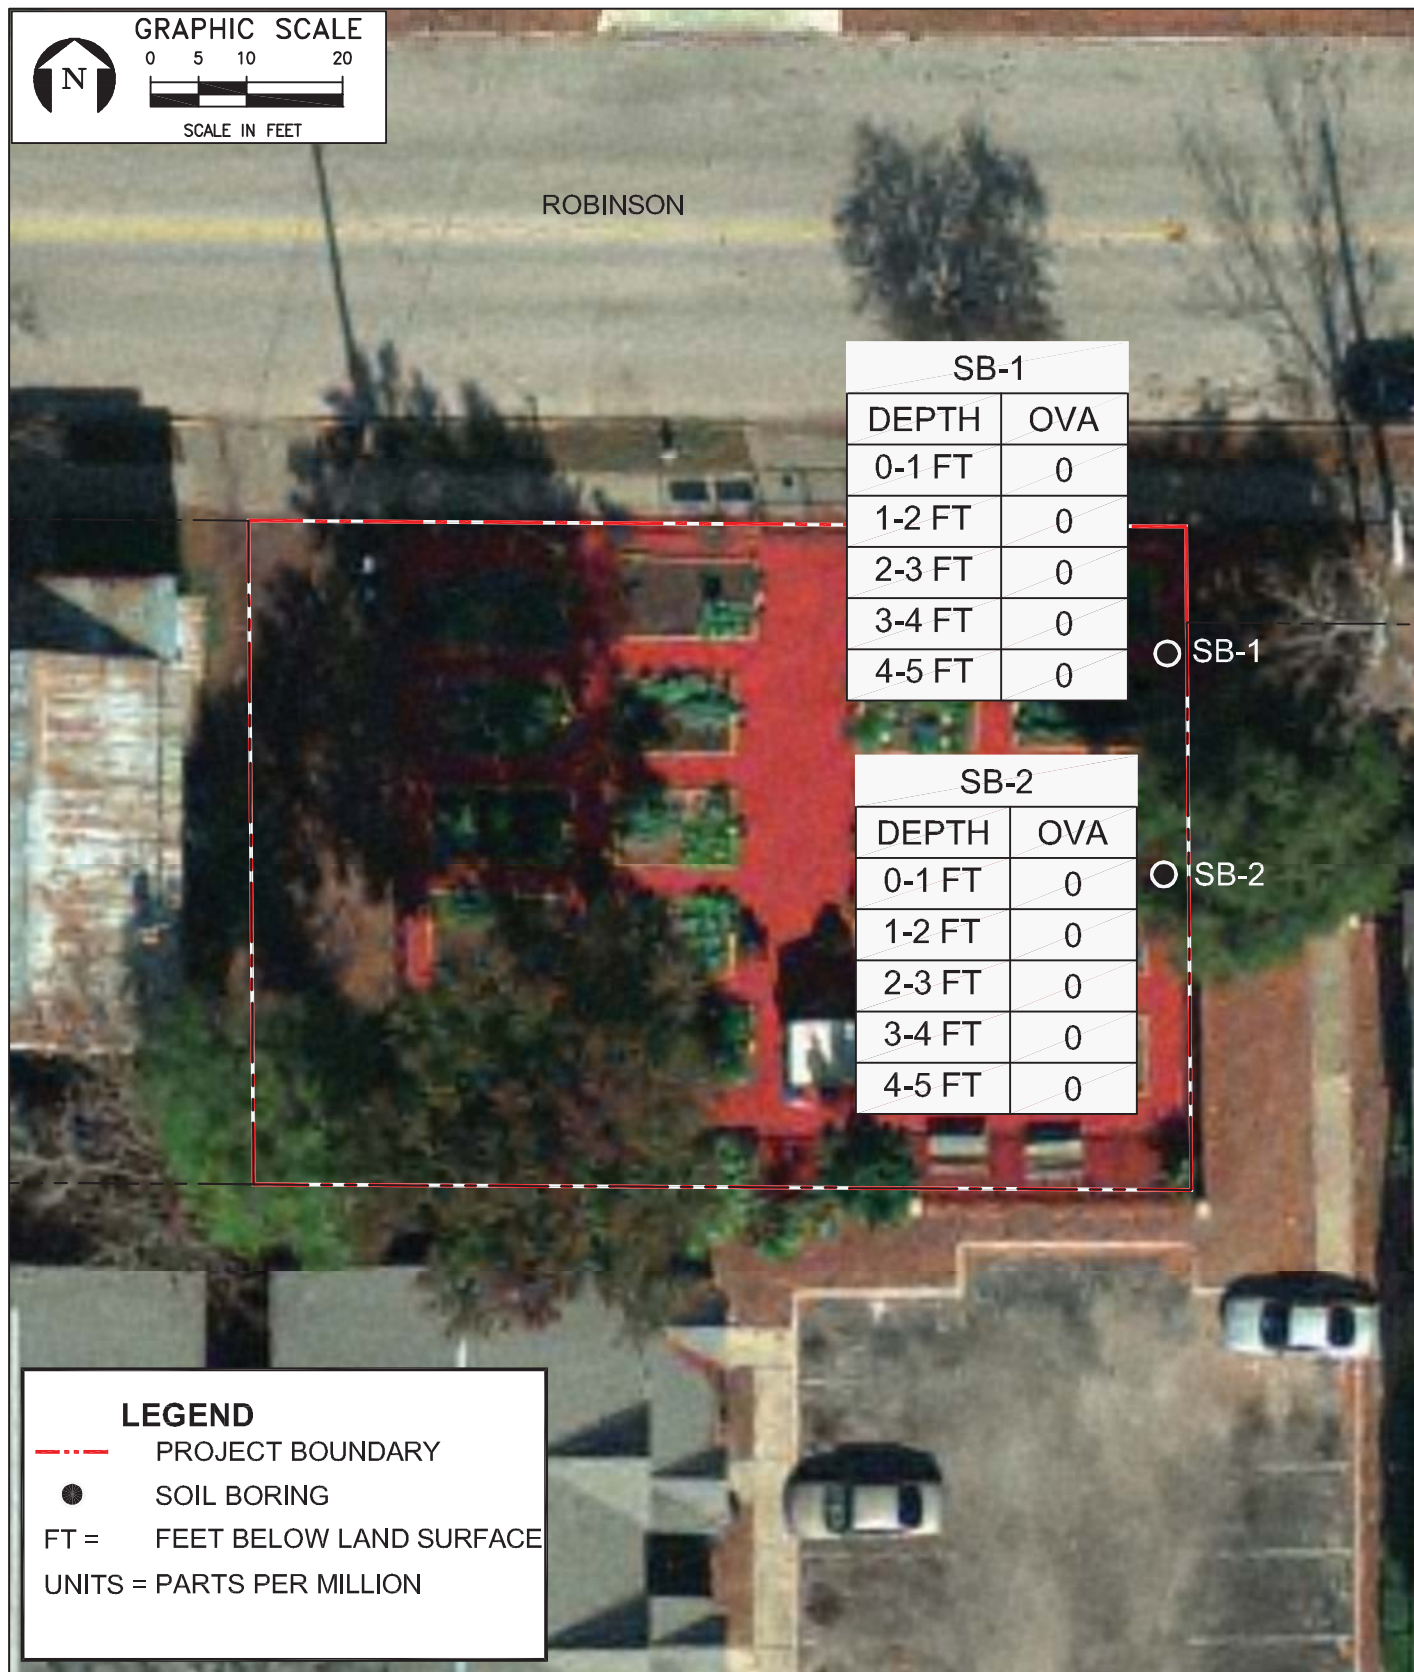
FIGURE 3.
SOIL SCREENING SUMMARY - AUGUST 20, 2014
654 W ROBINSON STREET
ORLANDO, ORANGE COUNTY, FLORIDA
SECTION 26, TOWNSHIP 22S, RANGE 29E
SOURCE: ECT, 2014.

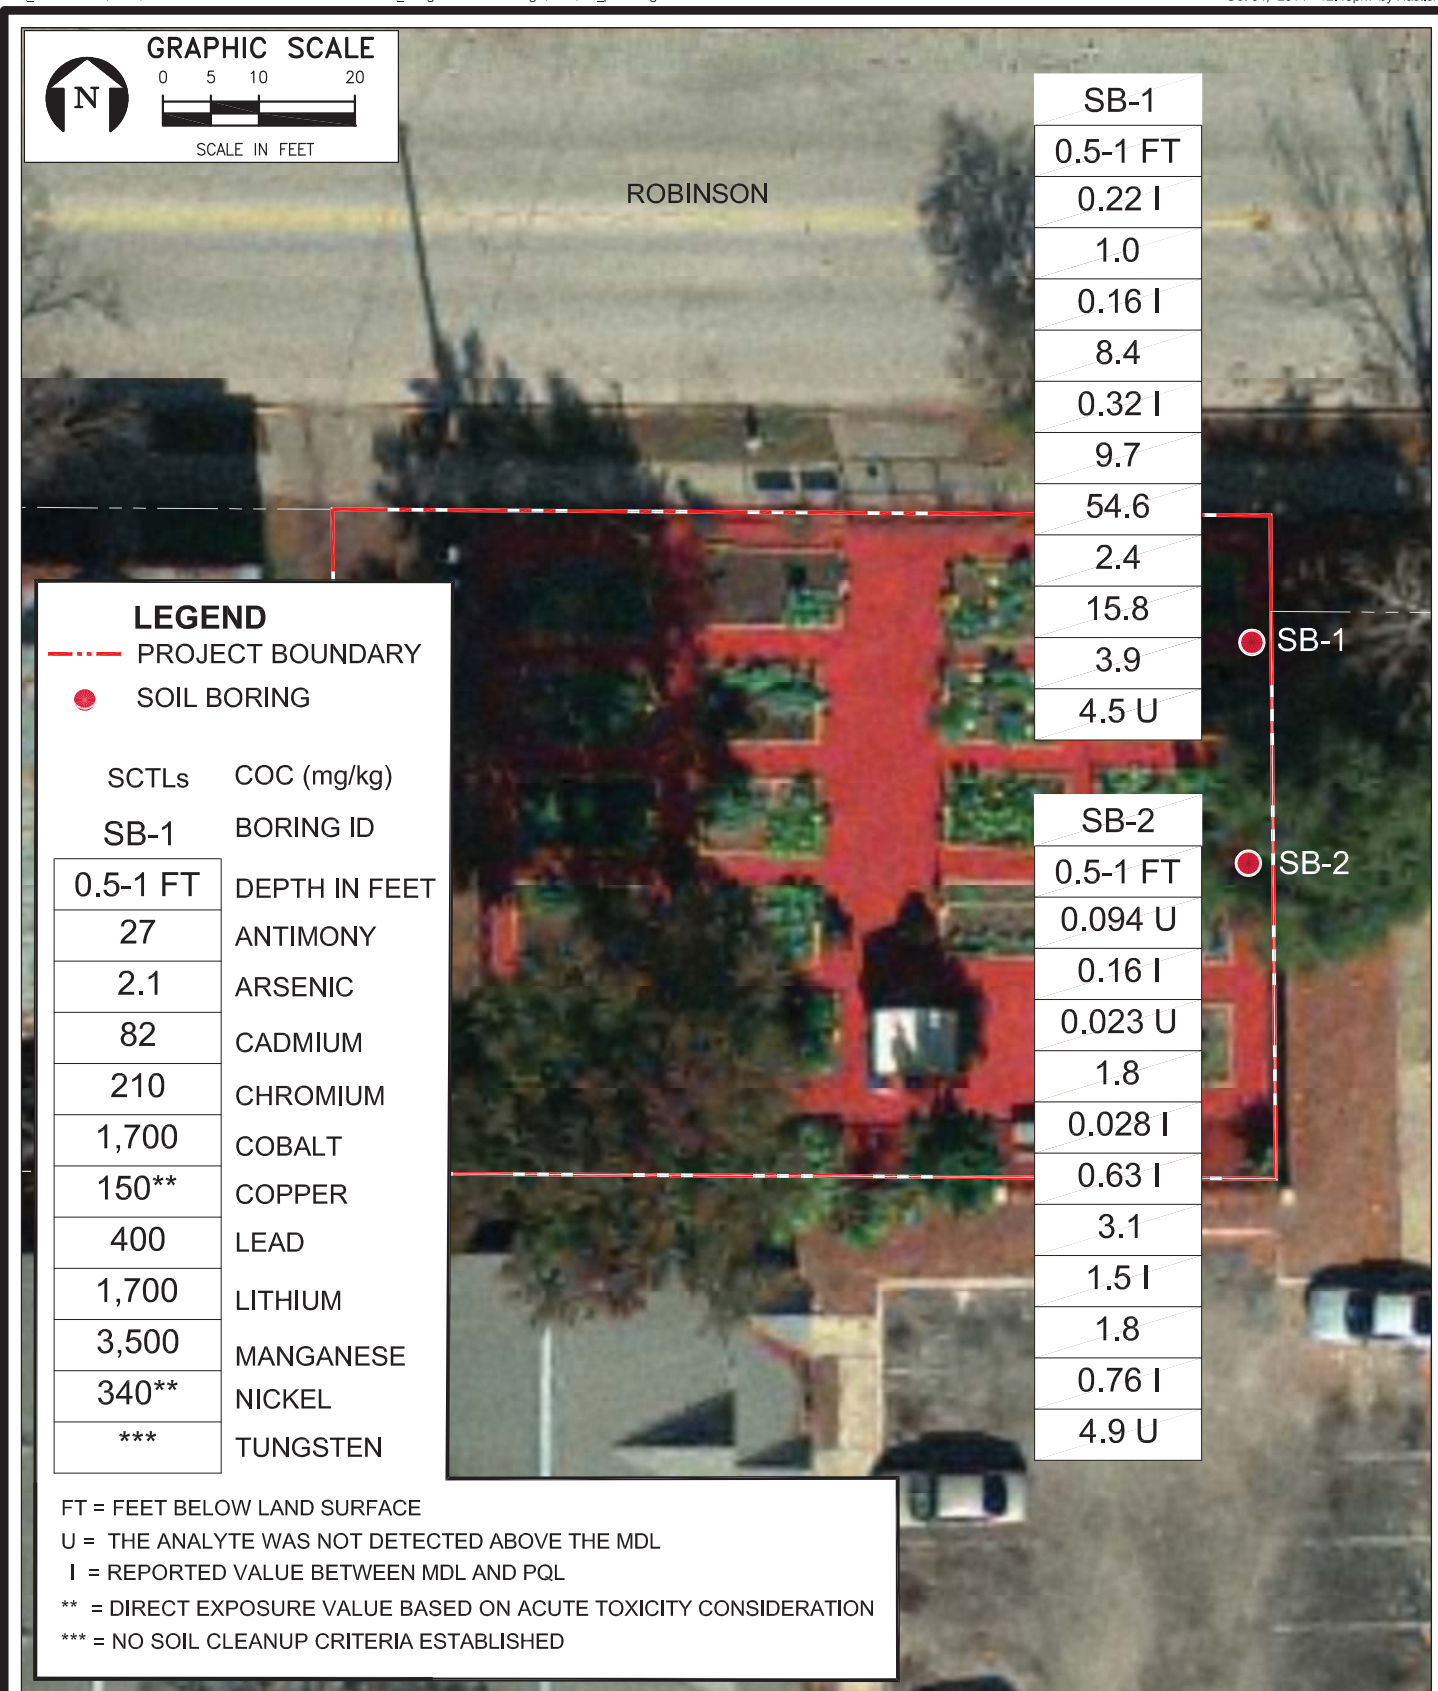
FIGURE 4.
 SOIL ANALYTICAL SUMMARY 0.5-1 FT - AUGUST 20, 2014
 654 W ROBINSON STREET
 ORLANDO, ORANGE COUNTY, FLORIDA
 SECTION 26, TOWNSHIP 22S, RANGE 29E
 SOURCE: ECT, 2014.

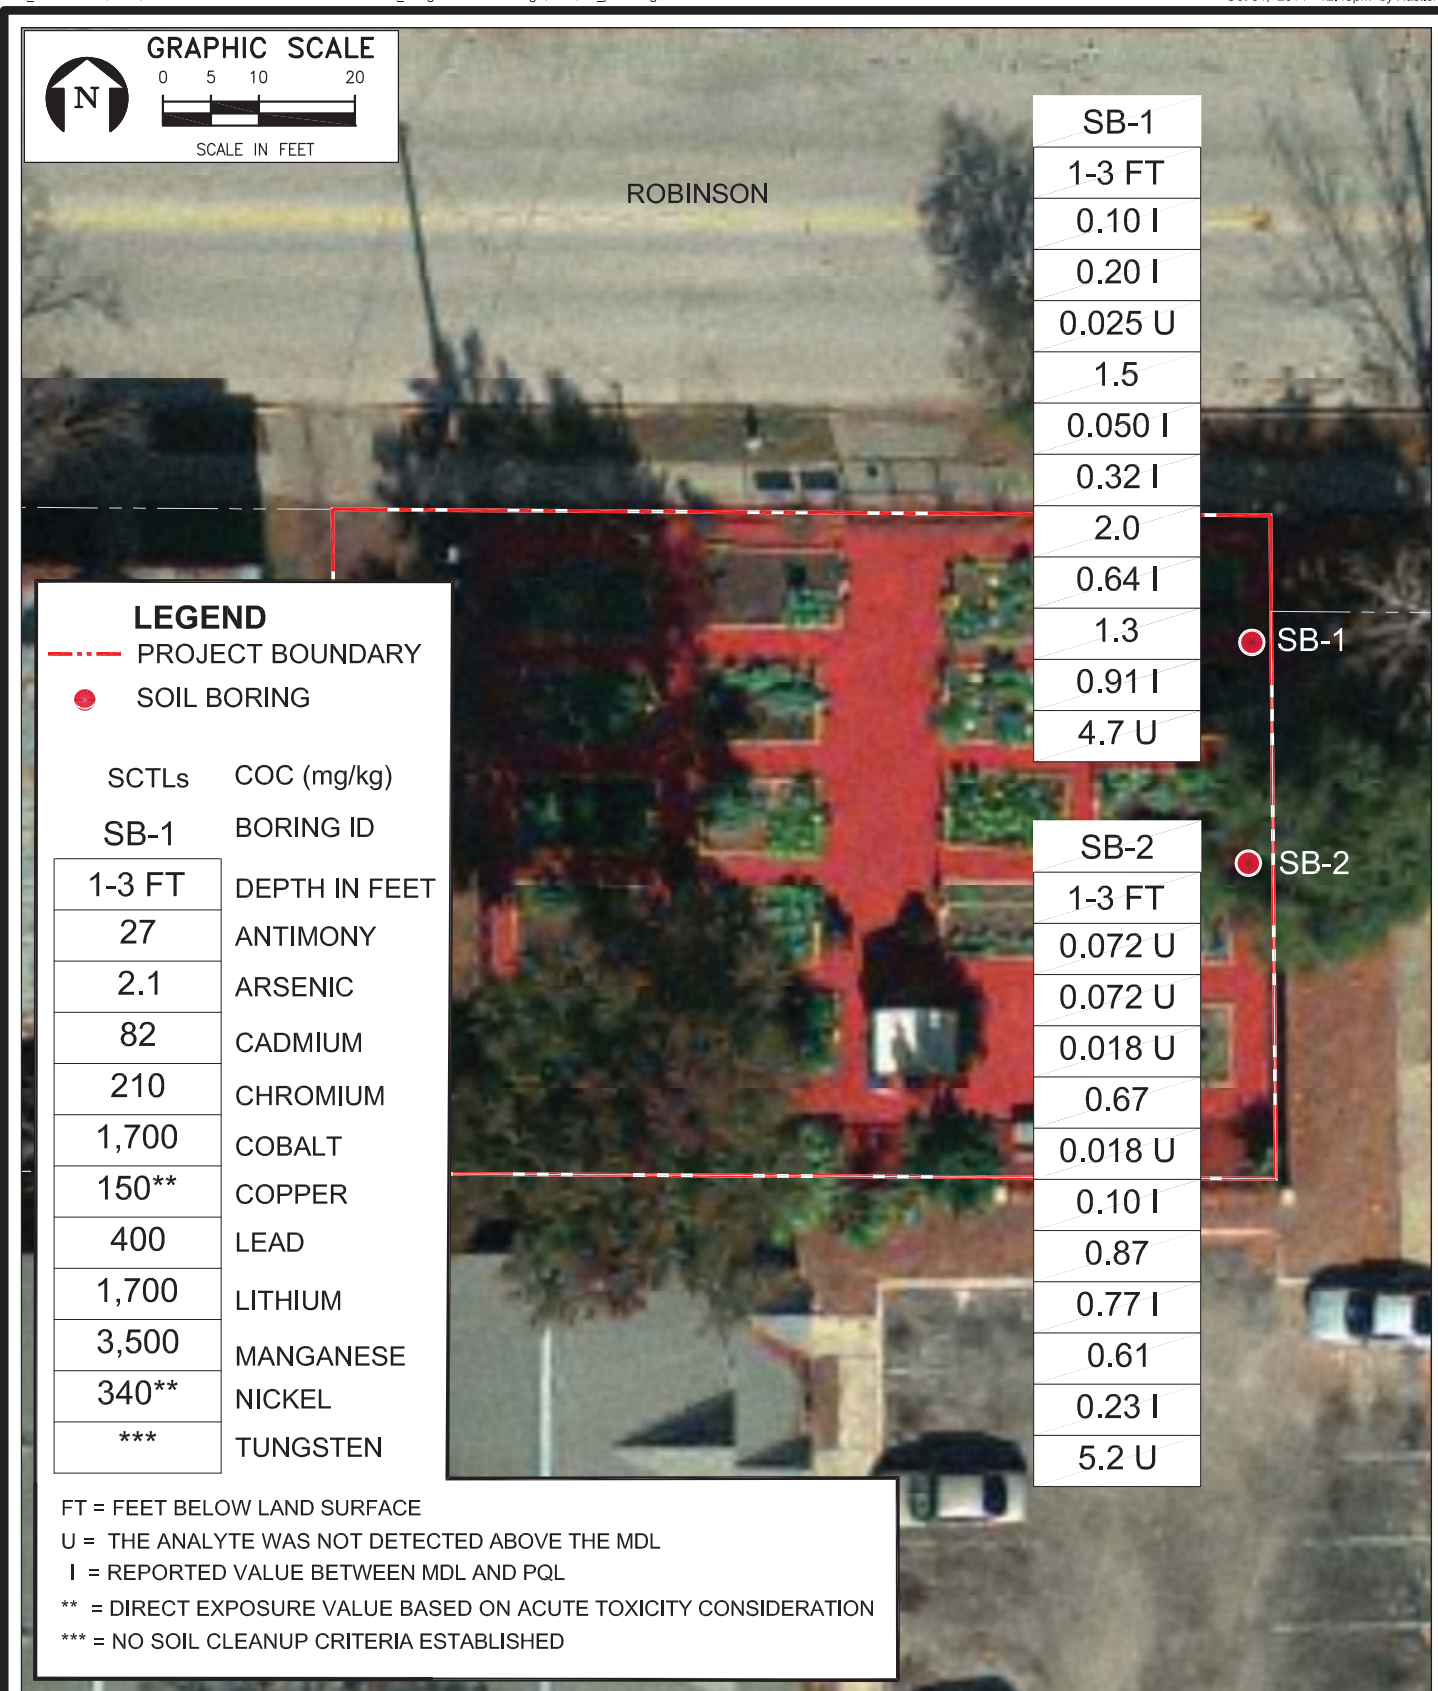
FIGURE 5.
 SOIL ANALYTICAL SUMMARY 1-3 FT - AUGUST 20, 2014
 654 W ROBINSON STREET
 ORLANDO, ORANGE COUNTY, FLORIDA
 SECTION 26, TOWNSHIP 22S, RANGE 29E
 SOURCE: ECT, 2014.

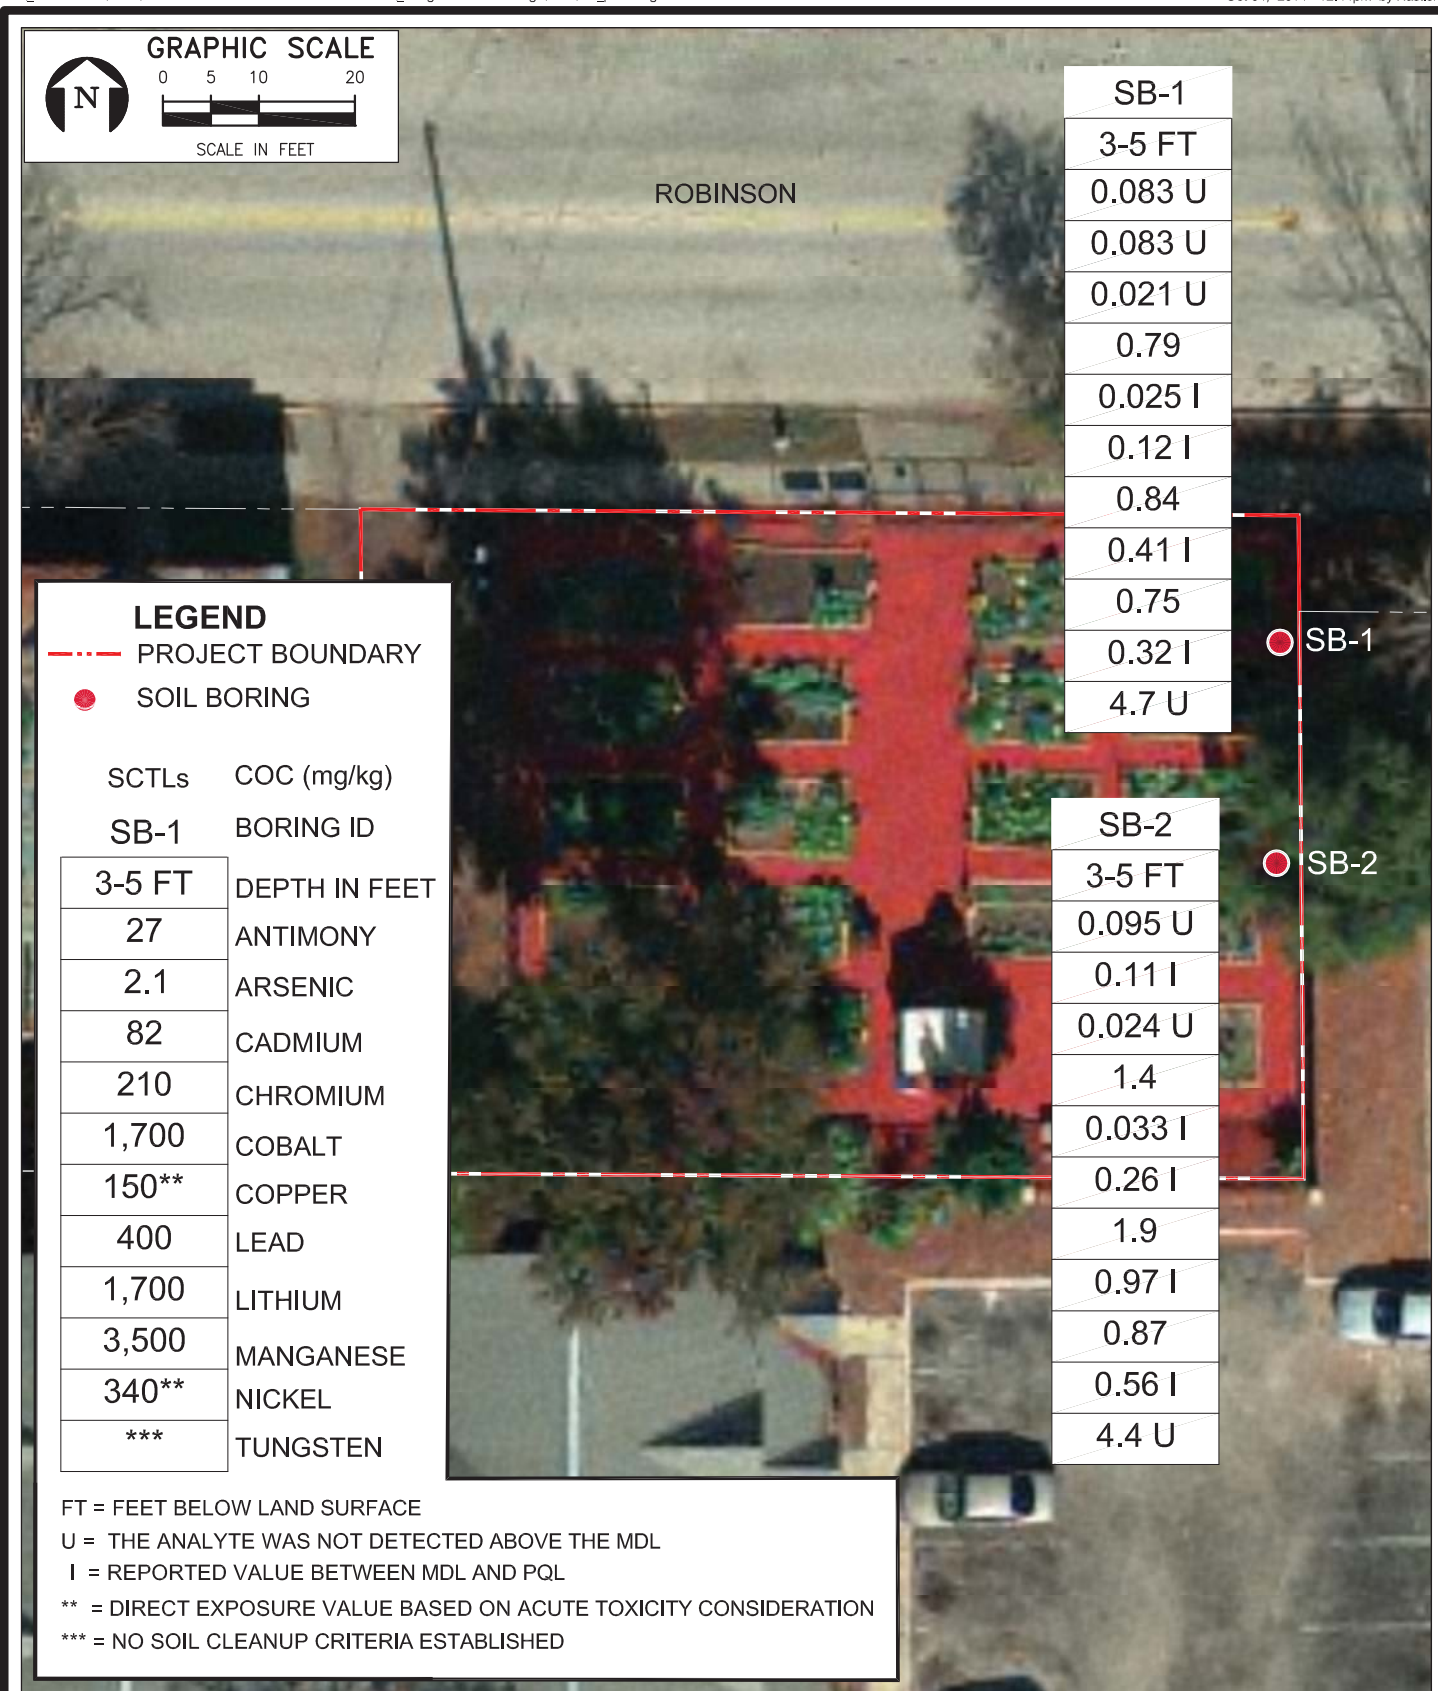
FIGURE 6.
SOIL ANALYTICAL SUMMARY 3-5 FT - AUGUST 20, 2014
654 W ROBINSON STREET
ORLANDO, ORANGE COUNTY, FLORIDA
SECTION 26, TOWNSHIP 22S, RANGE 29E
SOURCE: ECT, 2014.

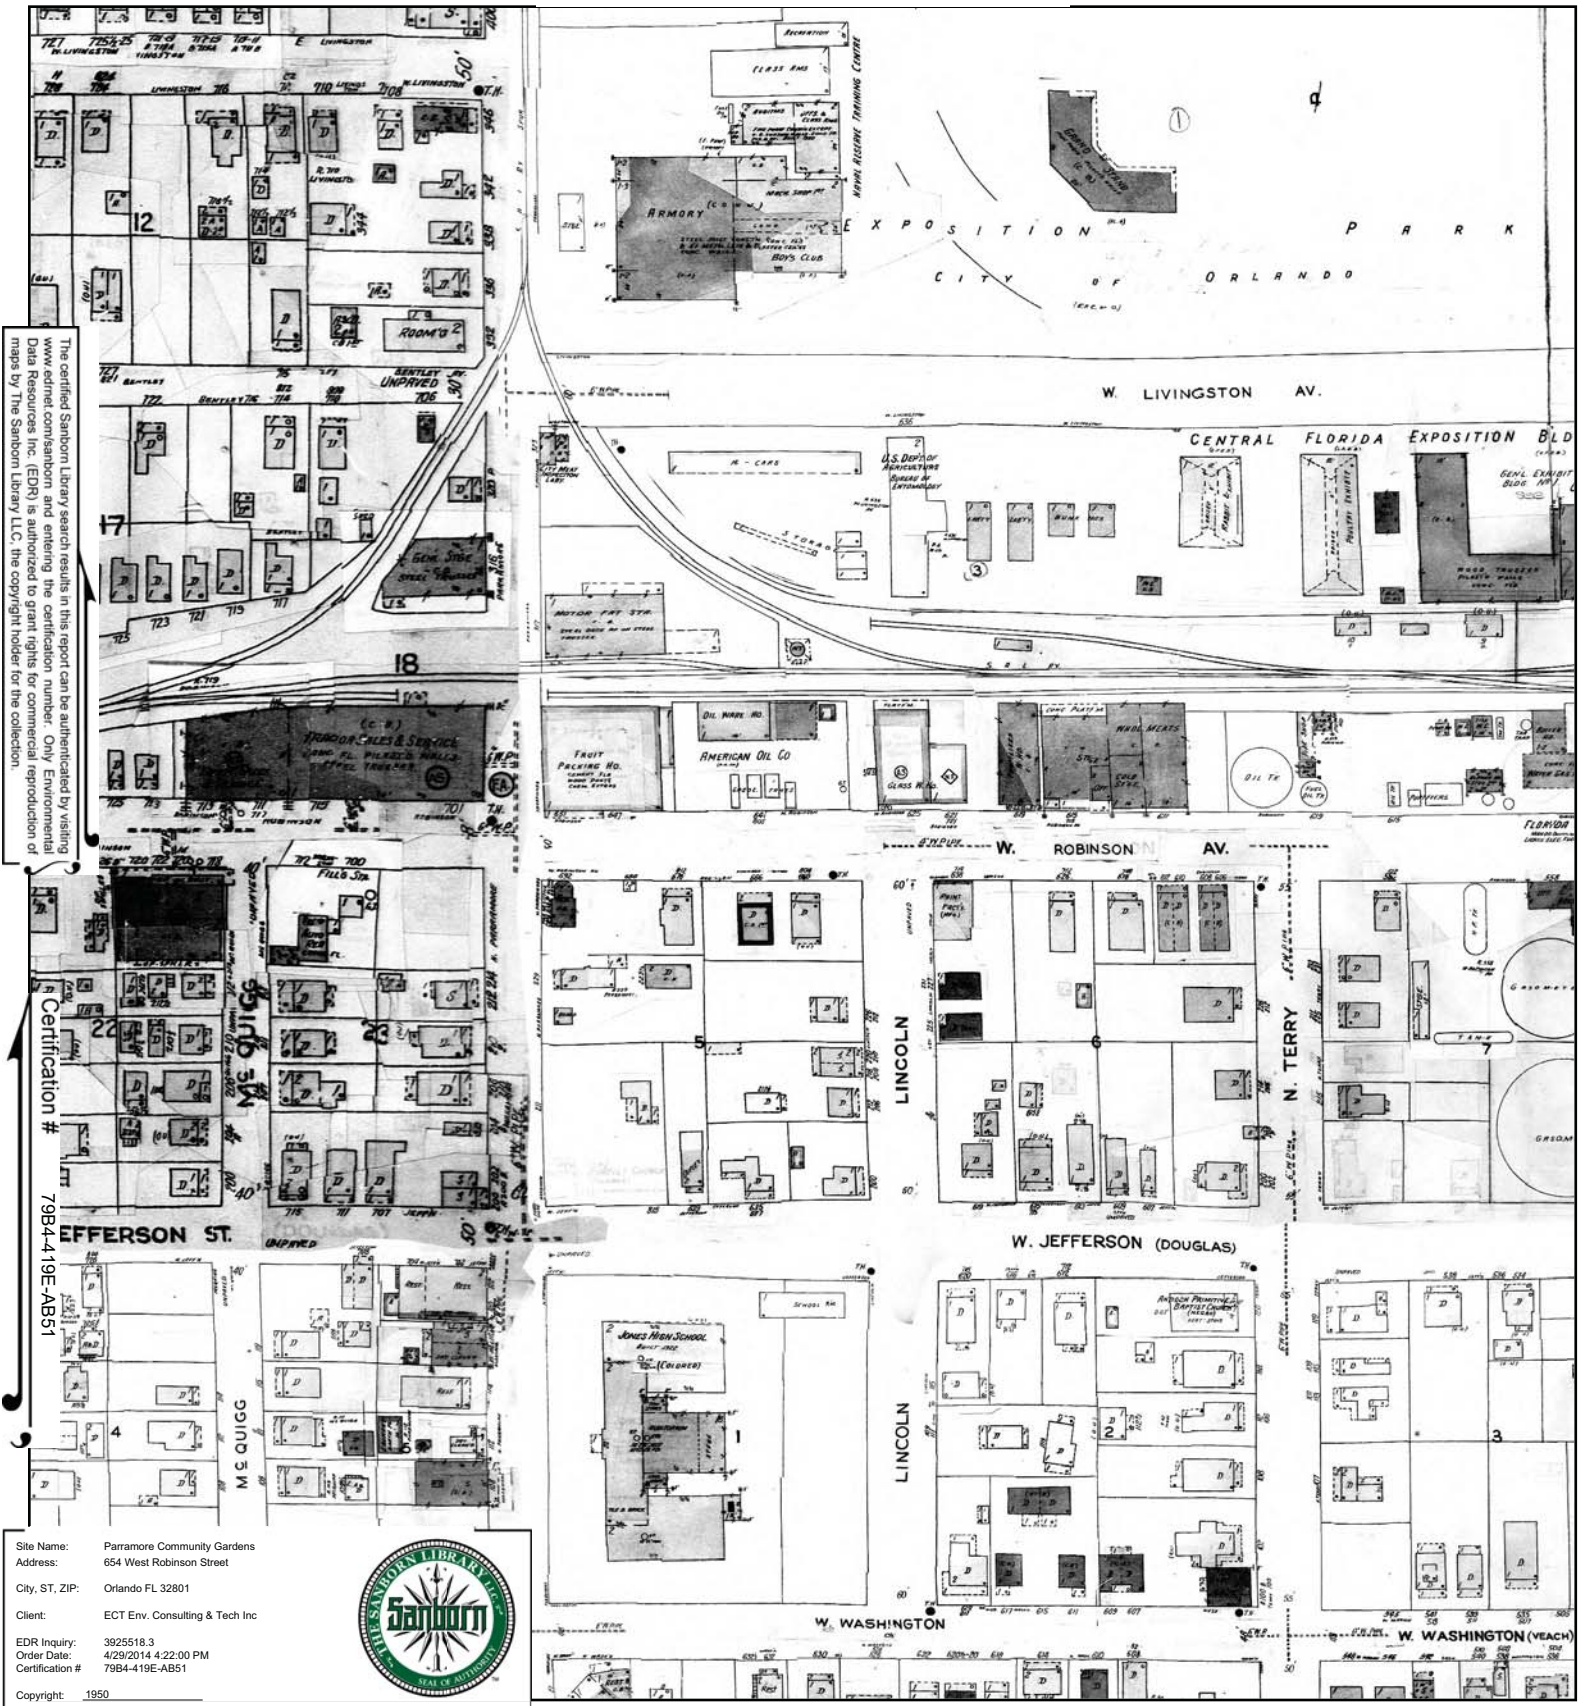
1950 Certified Sanborn Map

property northwest of the Site across West Robinson Avenue. Residential dwellings and vacant property exists to the west, south and east. Also located east of the Site across Lincoln Avenue is a paint factory (manufacturing).
