**PHASE II
ENVIRONMENTAL SITE ASSESSMENT
ORLANDO DOWNTOWN RECREATION COMPLEX
AND TENNIS CENTRE PARCEL
649 BENTLEY STREET
ORLANDO, ORANGE COUNTY, FLORIDA**

**The City of Orlando
Economic Development Department
400 S. Orange Avenue
Orlando, Florida, 32802-4990
EPA Brownfield Cooperative Agreement BF-95498212**

**ECT No. 130842 & 140365
August 2014**

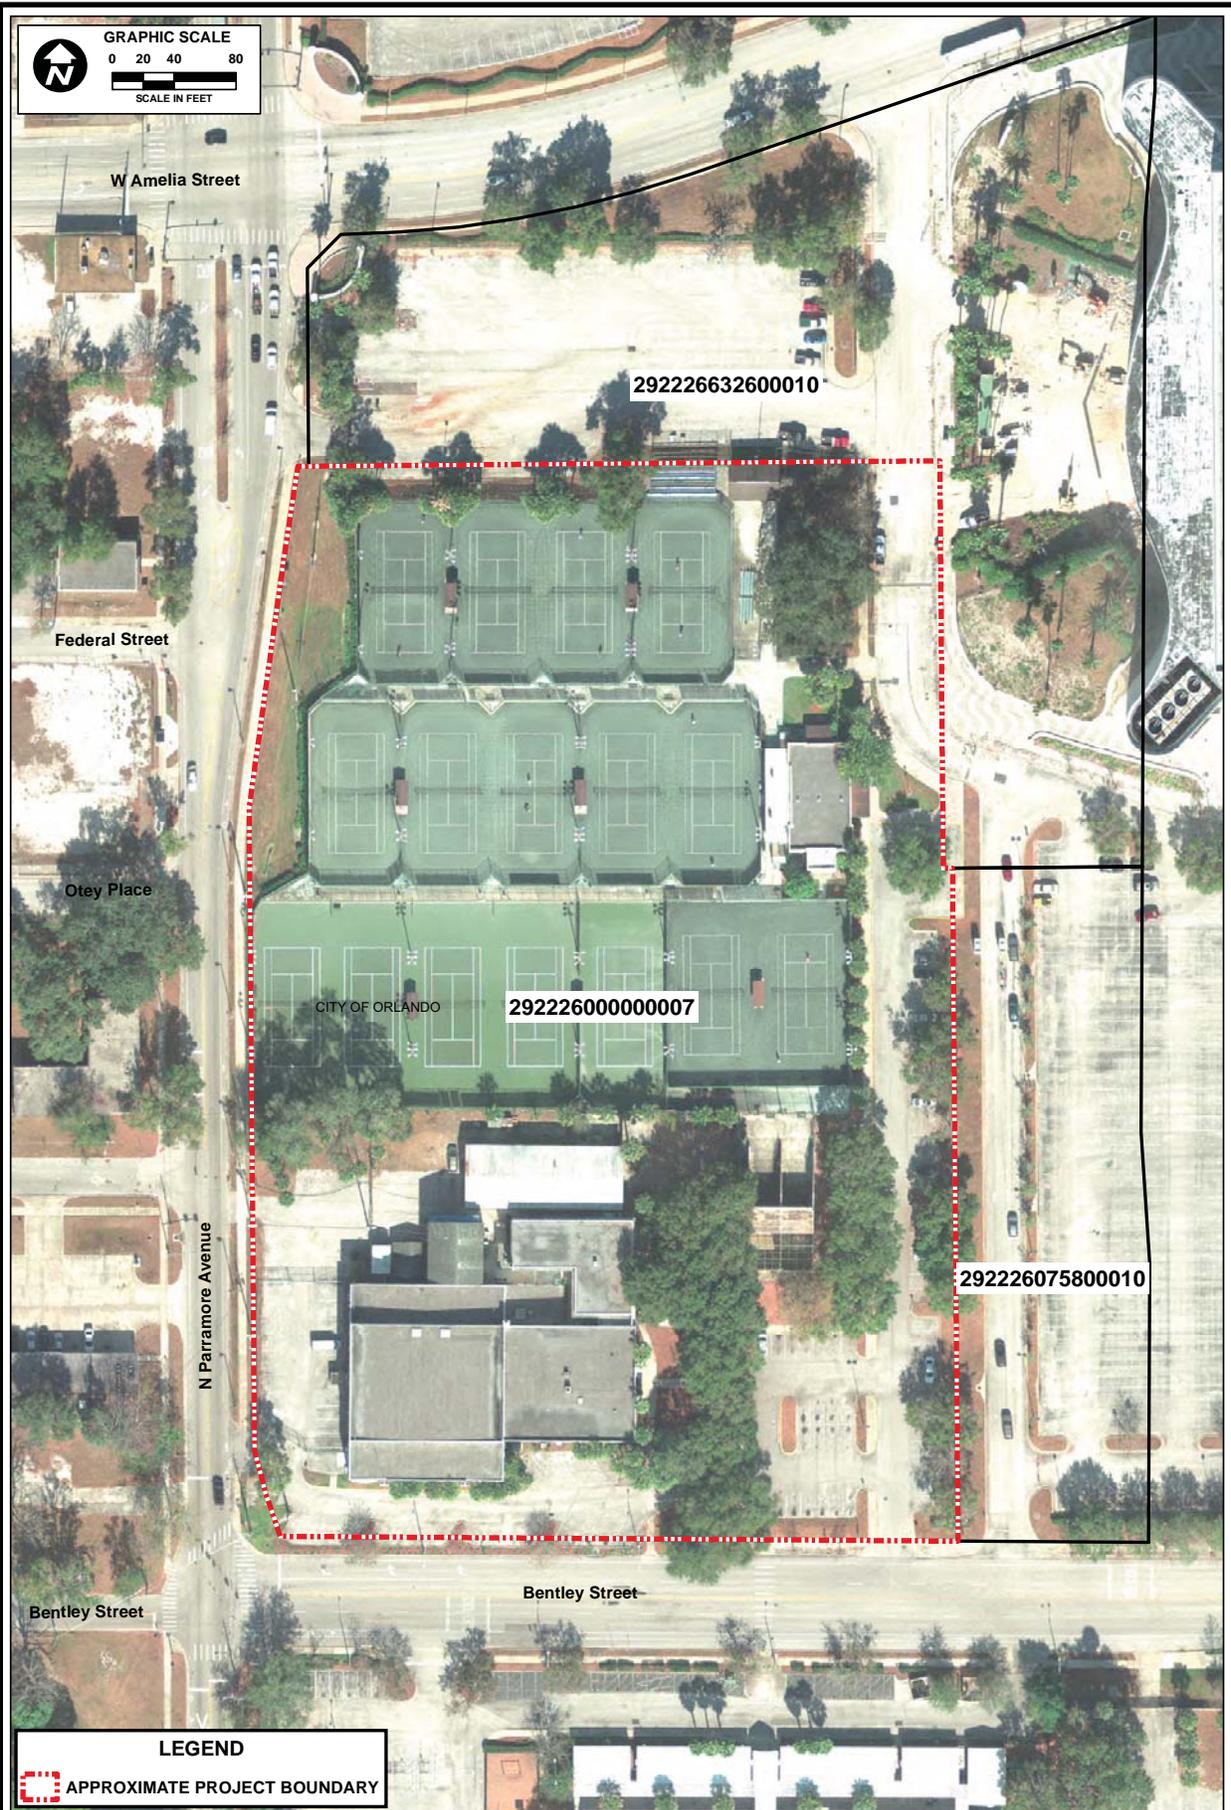
FIGURE 3.
 SITE PLAN
 ORLANDO DOWNTOWN RECREATION COMPLEX & TENNIS CENTRE
 CITY OF ORLANDO, ORANGE COUNTY, FLORIDA
 SECTION 26, TOWNSHIP 22S, RANGE 29E
 SOURCE: FDOT Aerial, 2012; ECT, 2012.

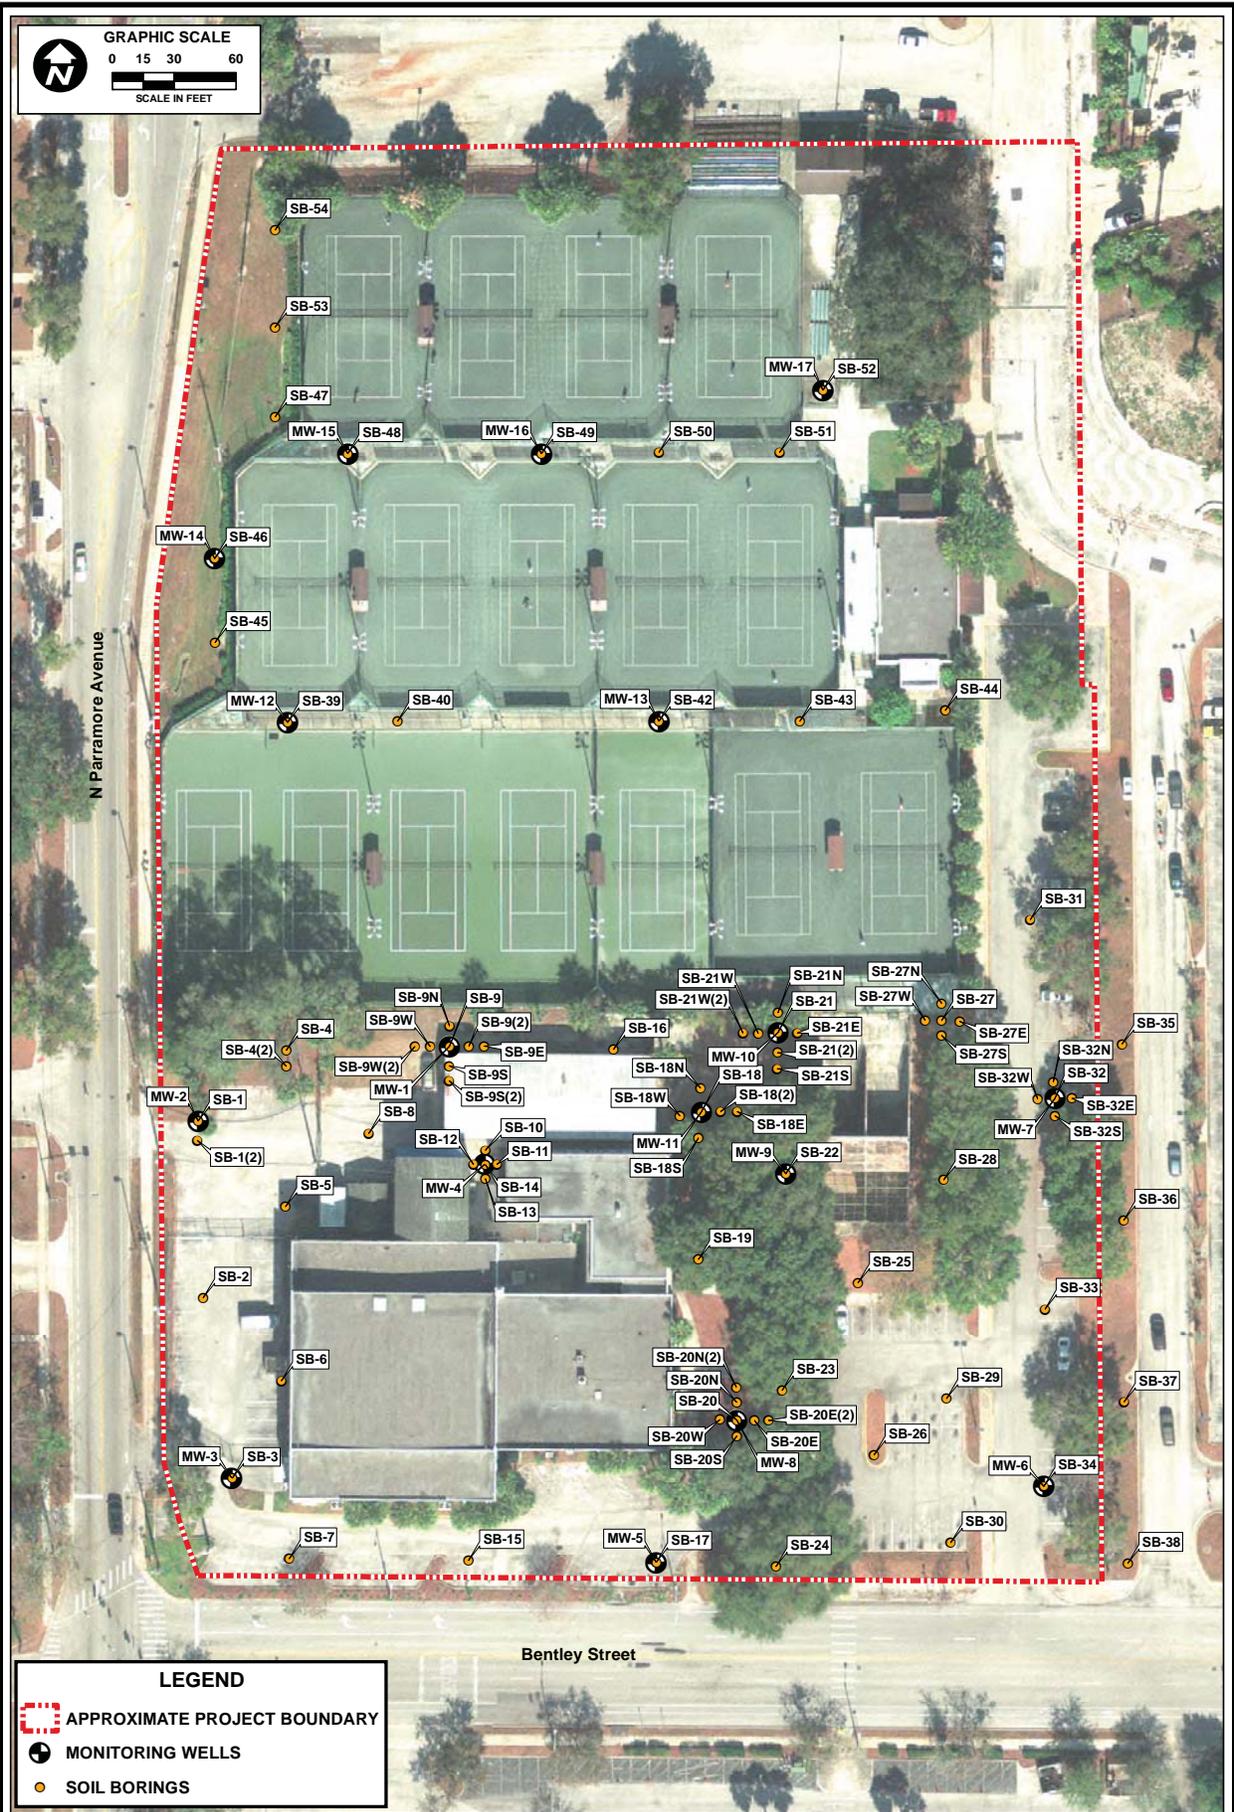
FIGURE 4.
 SOIL BORING AND MONITORING WELL LOCATIONS
 ORLANDO DOWNTOWN RECREATION COMPLEX & TENNIS CENTRE
 CITY OF ORLANDO, ORANGE COUNTY, FLORIDA
 SECTION 26, TOWNSHIP 22S, RANGE 29E
 SOURCE: FDOT Aerial, 2012; ECT, 2012.

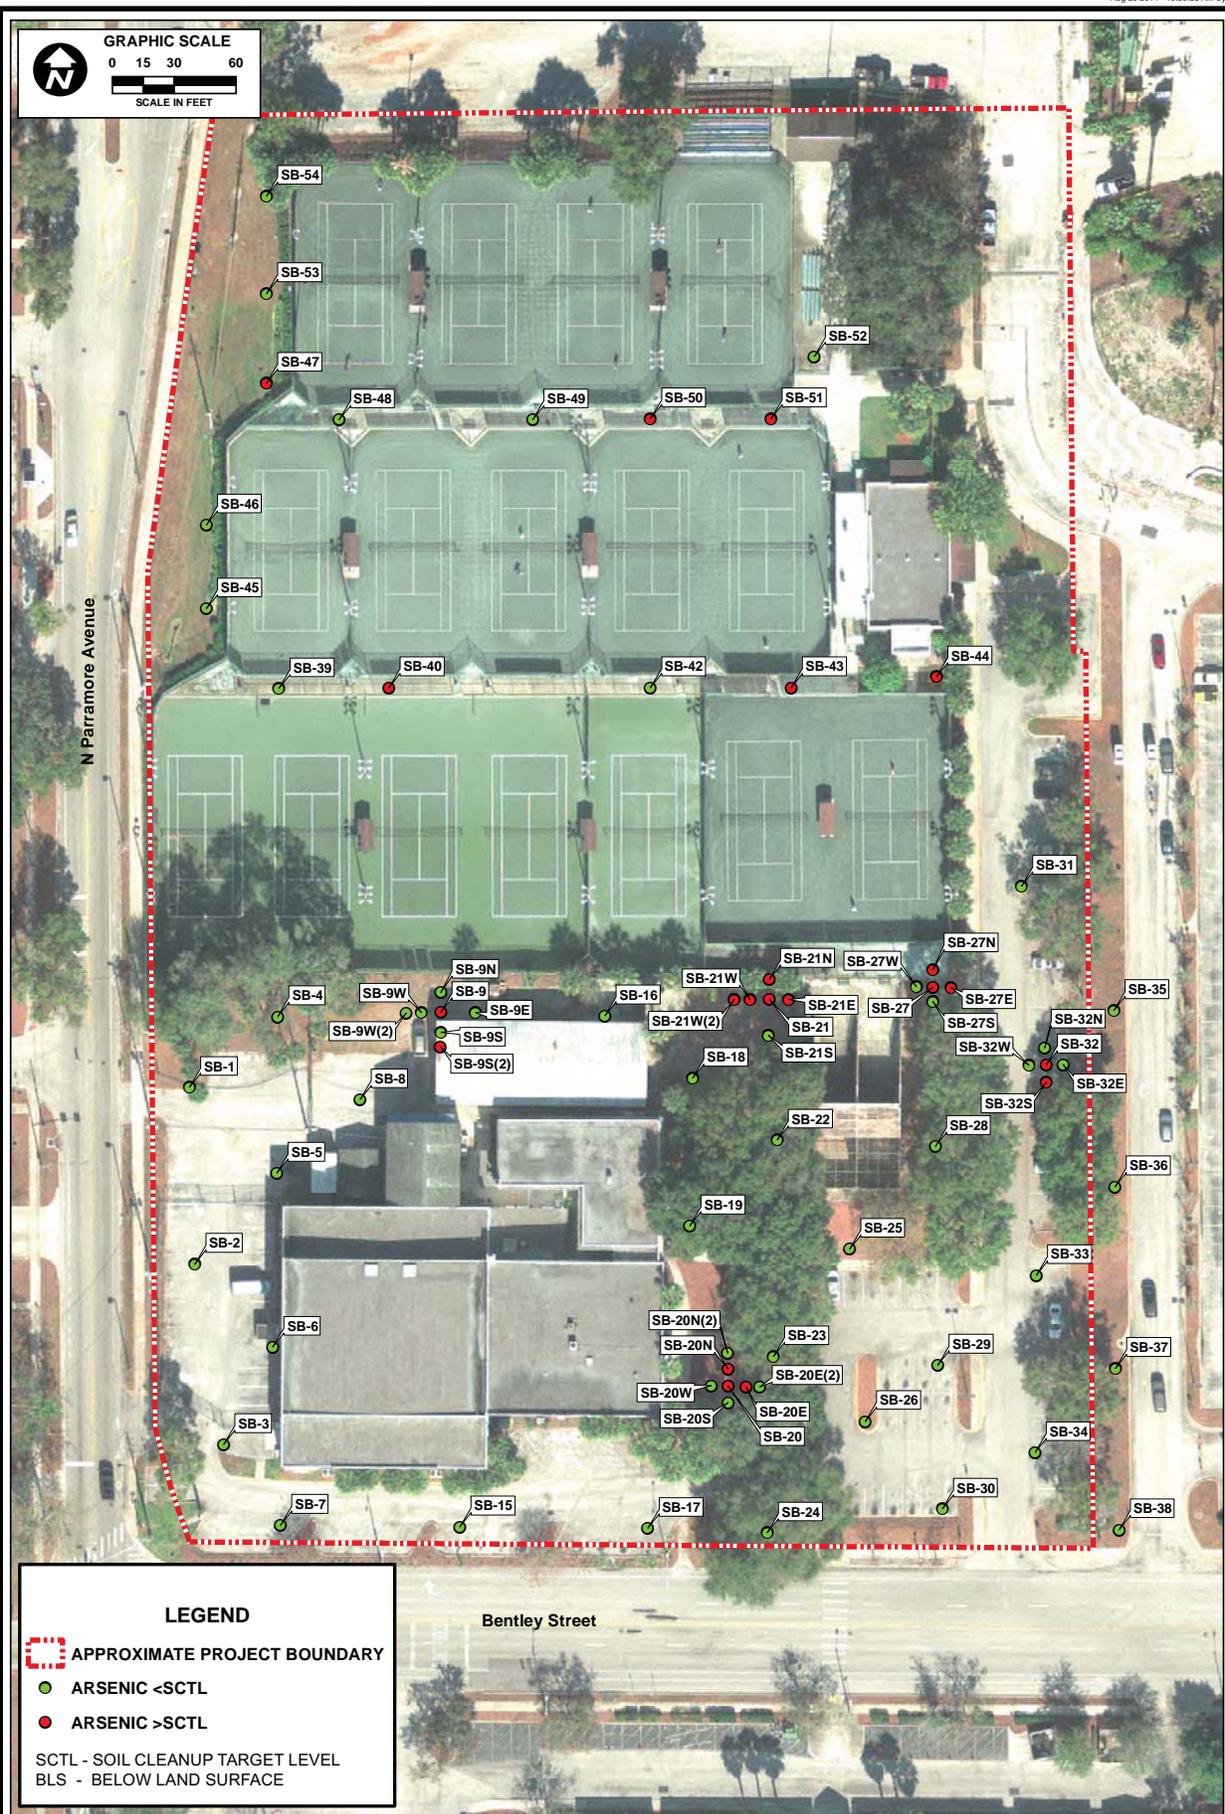
FIGURE 5.
ARSENIC 1-3 FT BLS
ORLANDO DOWNTOWN RECREATION COMPLEX & TENNIS CENTRE
CITY OF ORLANDO, ORANGE COUNTY, FLORIDA
SECTION 26, TOWNSHIP 22S, RANGE 29E
SOURCE: FDOT Aerial, 2012; ECT, 2012.

SB-40, SB-43, 50, and SB-51: The arsenic impacts detected at these locations are within the tennis courts, which acts as an engineering control preventing direct exposure to the soil. No further assessment or remedial activities are recommended within the tennis court area at this time. If at a future date the tennis courts are removed, or this area is repurposed for greenspace, additional assessment and/or remedial activities may be required.

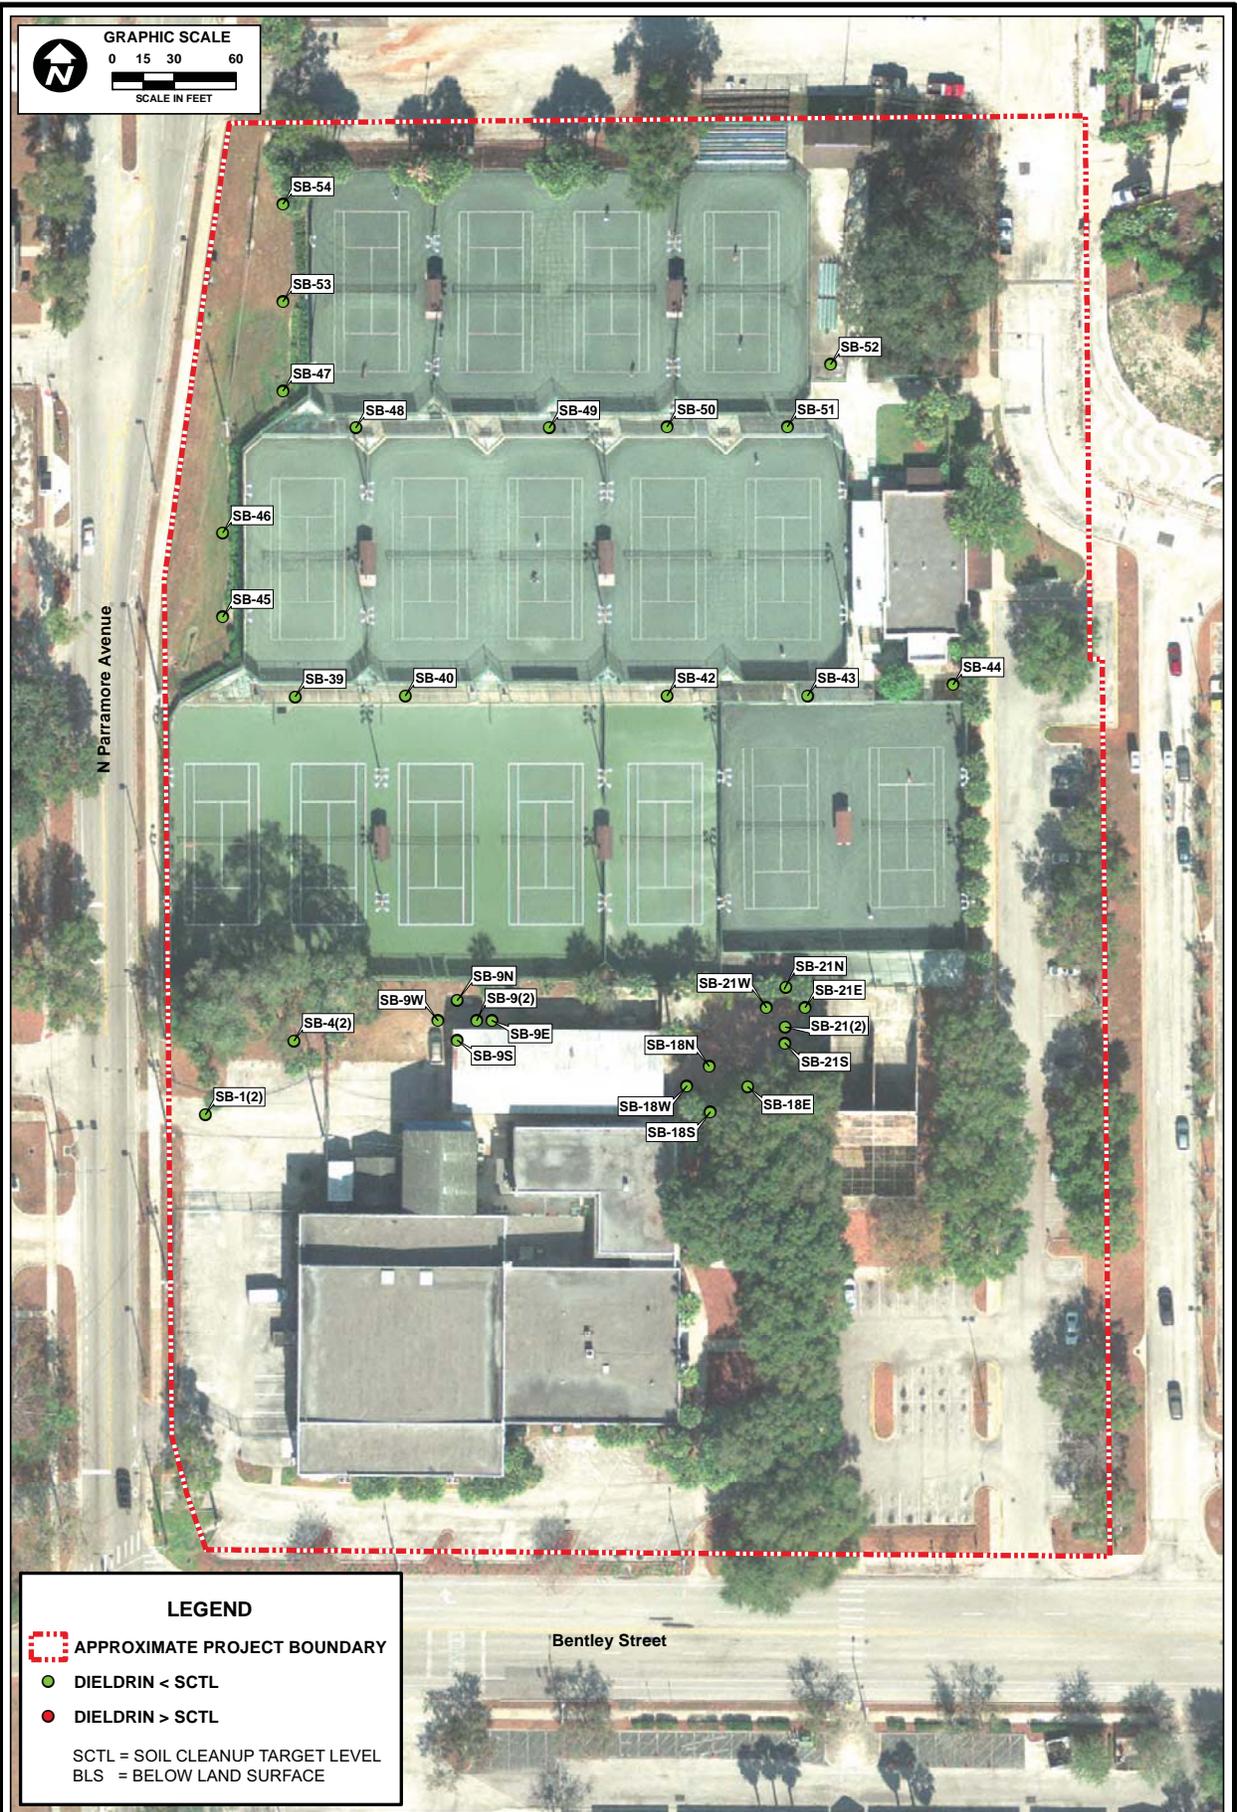
FIGURE 6.
DIELDRIN 1-3 FT BLS
ORLANDO DOWNTOWN RECREATION COMPLEX & TENNIS CENTRE
CITY OF ORLANDO, ORANGE COUNTY, FLORIDA
SECTION 26, TOWNSHIP 22S, RANGE 29E
SOURCE: FDOT Aerial, 2012; ECT, 2012.

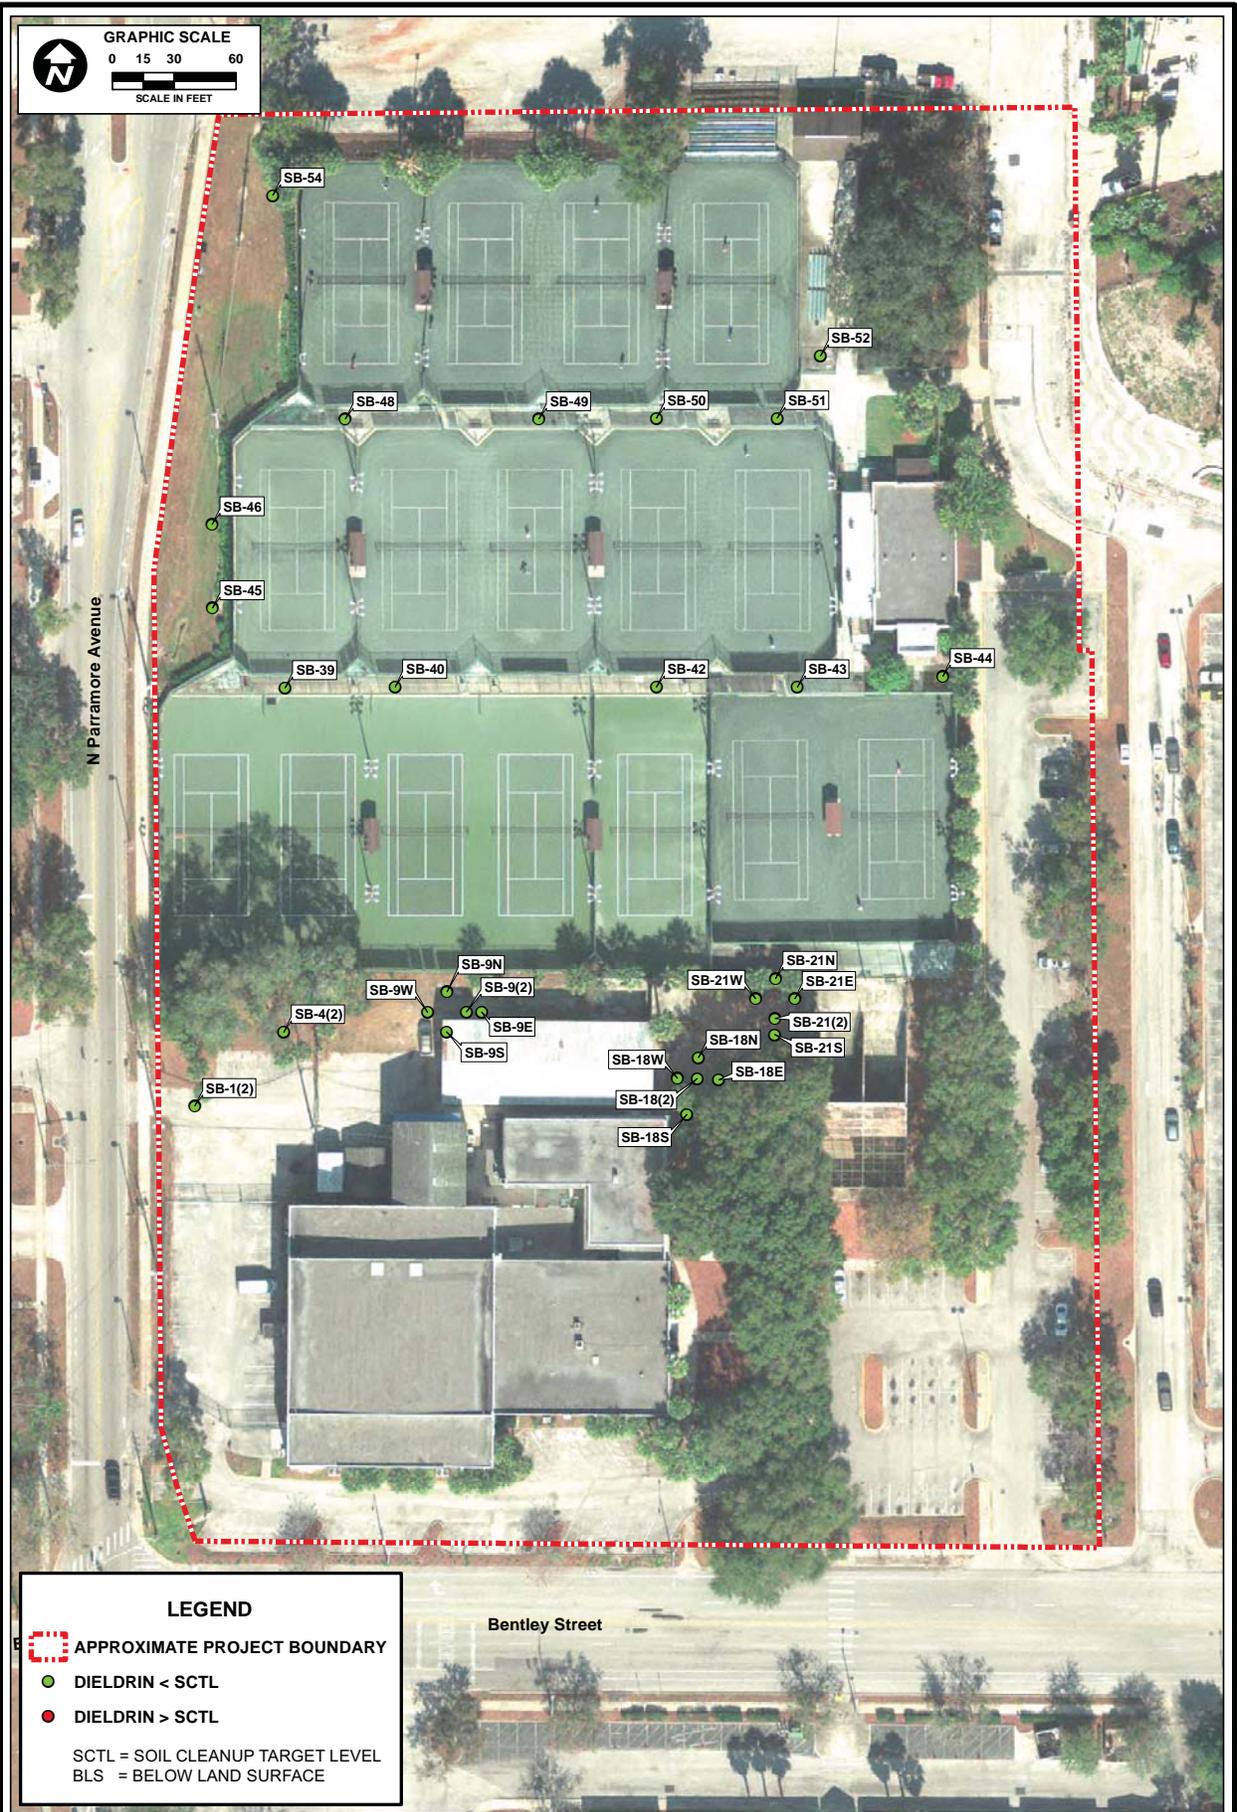
FIGURE 8.
DIELDRIN 3-5 FT BLS
ORLANDO DOWNTOWN RECREATION COMPLEX & TENNIS CENTRE
CITY OF ORLANDO, ORANGE COUNTY, FLORIDA
SECTION 26, TOWNSHIP 22S, RANGE 29E
SOURCE: FDOT Aerial, 2012; ECT, 2012.

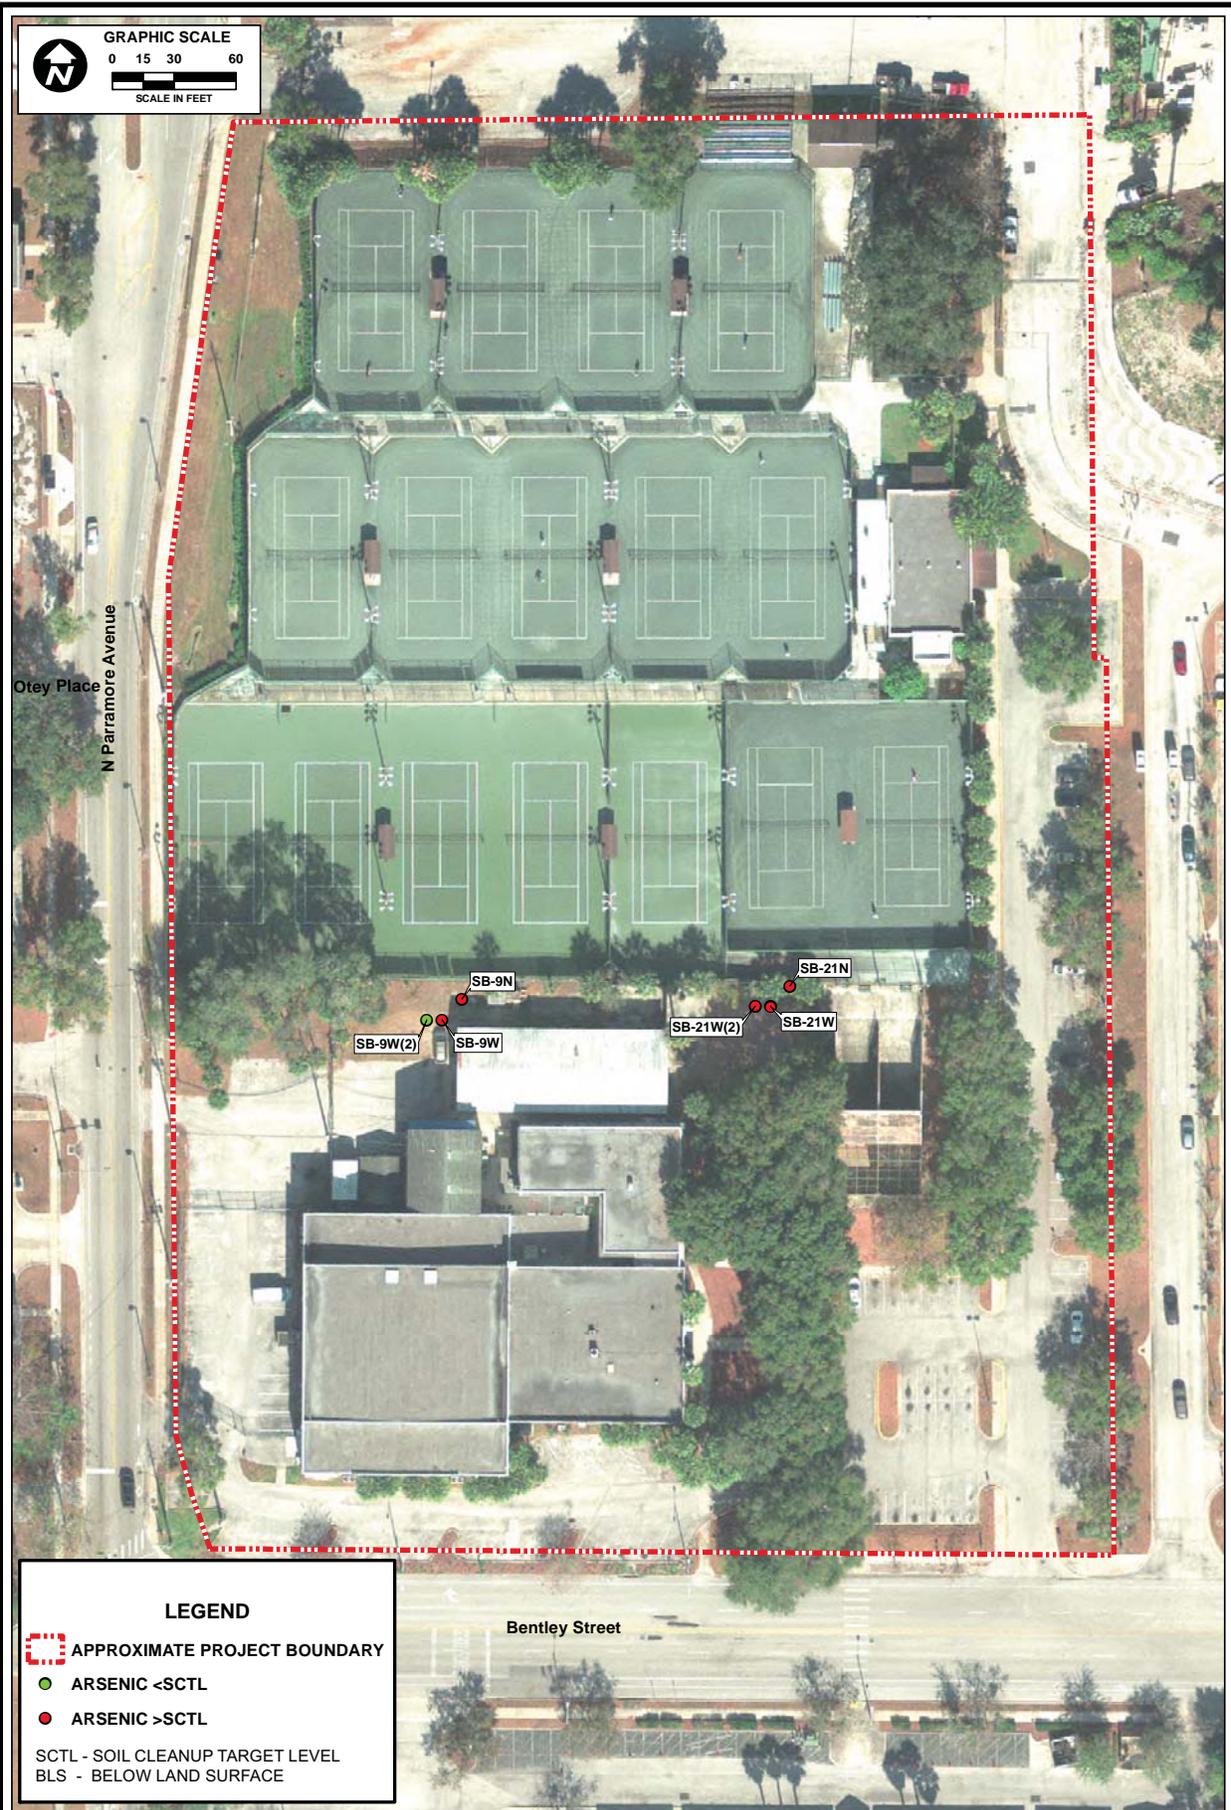
FIGURE 9.
ARSENIC 5-7 FT BLS
ORLANDO DOWNTOWN RECREATION COMPLEX & TENNIS CENTRE
CITY OF ORLANDO, ORANGE COUNTY, FLORIDA
SECTION 26, TOWNSHIP 22S, RANGE 29E
SOURCE: FDOT Aerial, 2012; ECT, 2012.
