Bike and Pedestrian Safety Recommendations Technical Memorandum

April 27, 2023

CITY OF
ORLANDO

SOUTHWEST BIKE AND PEDESTRIAN STUDY

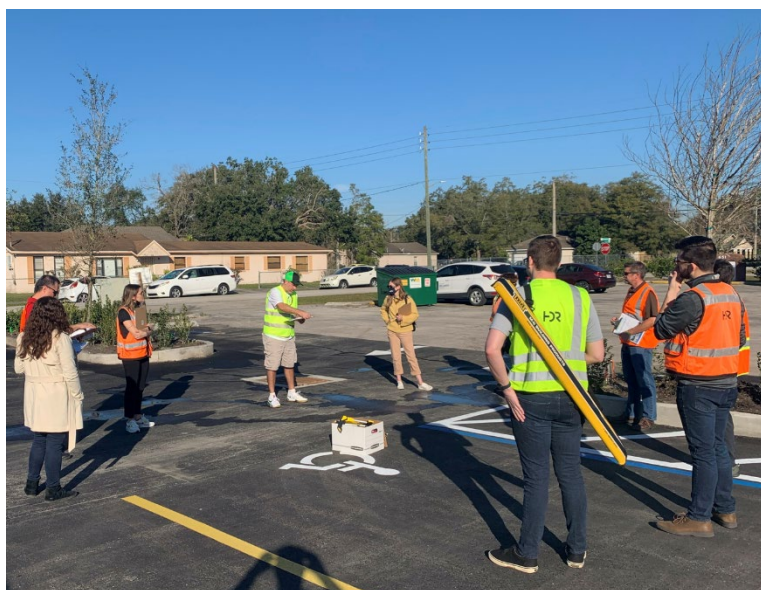
Safety Audit team members meeting prior conducting the safety audit of Ivey Lane.

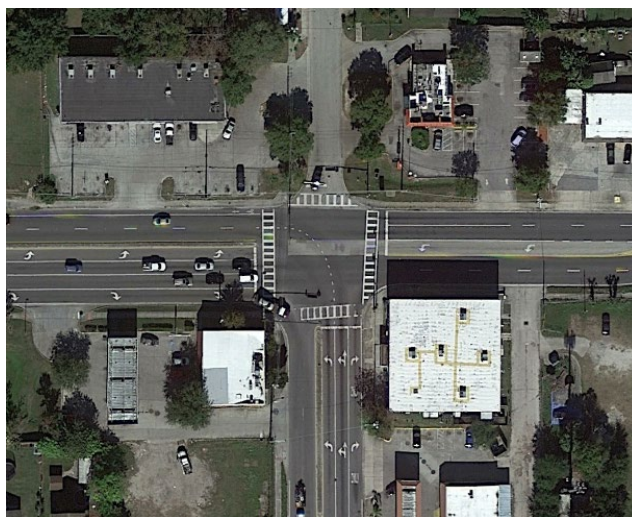
- In accordance with ADA best practices, separate curb ramps should be created for each directional crossing. At a minimum, detectable warning surfaces should be added to the ramps on the north side of the

Aerial of Columbia Street and Bruton Boulevard/Henton Lane intersection.

- The eastbound bike lane on Columbia Street terminates on the approach to this intersection. Ideally, as a longer-term solution, this bike lane should be extended through the intersection and east on Columbia Street. In the meantime, adding a Bike Lane Ends sign would alert unsuspecting bicyclists to this condition.
- In accordance with findings from the OUC photometric study, replace the existing light fixtures on all four intersection corners with LED fixtures.
- As a low-cost safety countermeasure, retroreflective backplates can improve safety for all users by reducing crashes caused by driver inattentiveness and lighting- or weather-related impacts on signal visibility. Such backplates should be considered for installation at this intersection.

- To eliminate predominant turning conflicts, No Right Turn on Red blank-out signs for the eastbound and northbound approaches that illuminate when the pedestrian button is pushed should be considered. Similar pedestrian-activated Yield to Peds in Crosswalk blank out signs could also be considered for the intersection's left turn movements to alert motorists to the presence of pedestrians.

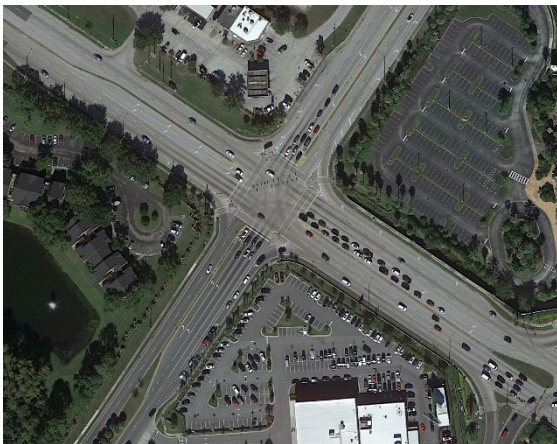
Aerial view of Conroy Road and Vineland Road intersection.

Conroy Road and Vineland Road are both principal arterial roadways and the intersection is located approximately 600 feet from the I-4 / Conroy Road interchange, making it an important intersection for efficient traffic flow. While the immediately surrounding land uses generate limited bicycle and pedestrian trips, nonmotorized activity is still prevalent for longer trips and there are several opportunities to make this large auto-oriented intersection more accommodating of those users.
